Beneficial Management Practices (BMPs) being assessed at the Stepler-South Tobacco Creek project

- Five beneficial management practices (BMPs) are being assessed within the Stepler-South Tobacco Creek Watershed as part of Agriculture and Agri-Food Canada's Watershed Evaluation of BMPs (WEBs) Project. The South Tobacco Creek Watershed sits approximately 150 kilometers southwest of Winnipeg, Manitoba, and is part of the Red River Basin. Over the past 15 years, numerous studies looking at the relationship between agricultural practices, water quality and water quantity have taken place in this small watershed. Agronomic and climate data collected through these studies have provided a great deal of background data for the WEBs study.

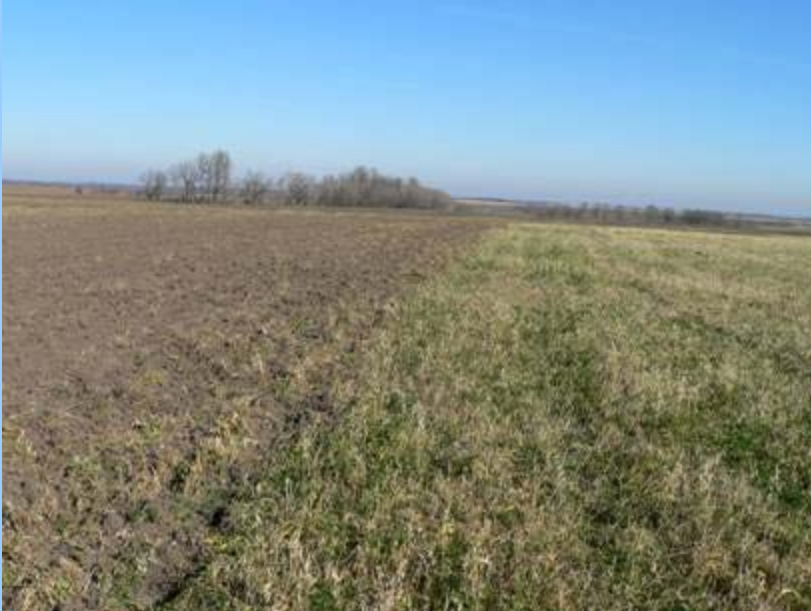
This photo shows the divide between two sub-watersheds (fields F1 and F2 [MAP](#)) farmed under two different practices. Land use for the watershed on the right has been converted to forage from annual crop. The watershed on the left remains in annual crop and has been cultivated after the crop was removed (a normal practice by the producer). The forage field was seeded with an oats cover crop and depicts late-season re-growth after alfalfa and oats were harvested. The water quantity and quality is being monitored for each of the two sub-watersheds to assess the impact of converting cropped land to forage. Two other sub-watersheds (fields F7 and F9 [MAP](#)) are being monitored for a similar comparison.

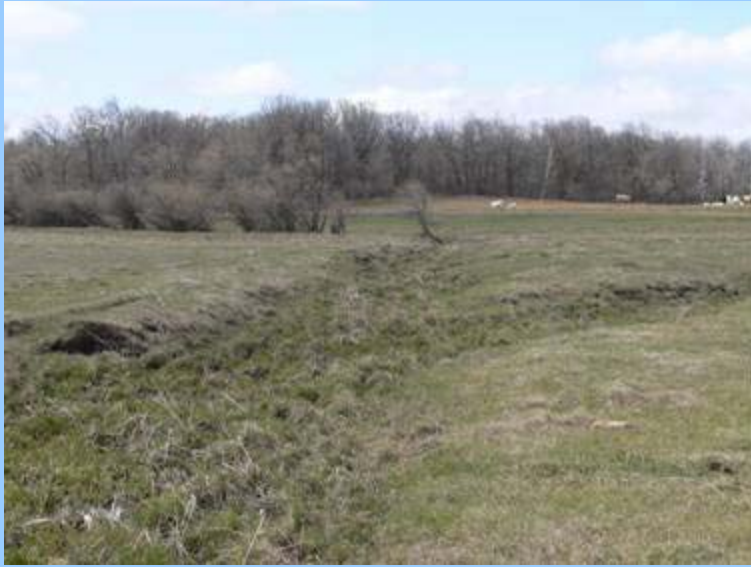
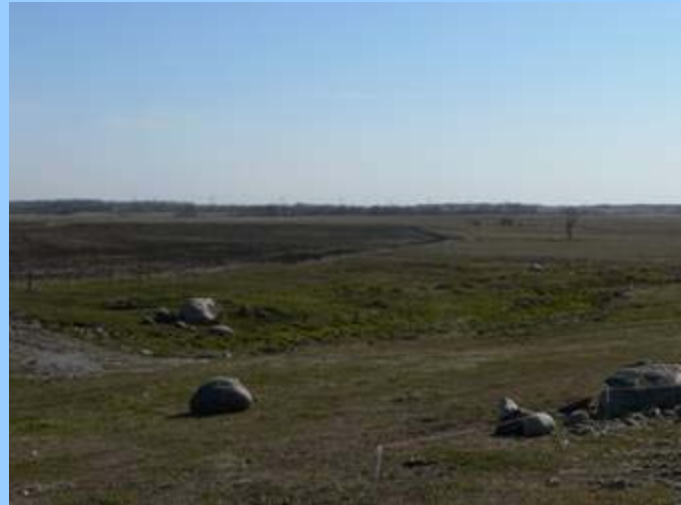
These two photos (above and to the right) depict a sub-watershed (field F5 [MAP](#)) used to pasture cattle and as a corridor to move cattle from the pasture areas to the farmyard for watering. As a result, the pasture and riparian areas were overgrazed. In order to improve the riparian, stream and pasture areas, the cattle have been given limited access to the pasture through the introduction of rotational grazing and an off-site (remote) watering system. The sub-watershed is not grazed beyond mid August.

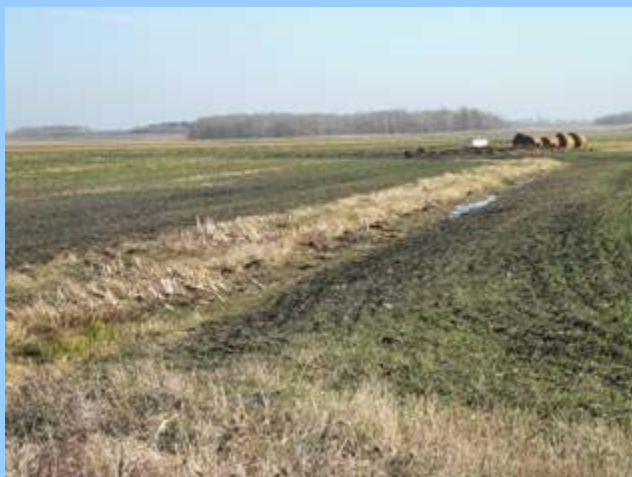
The stream within the sub-watershed (field F8 [MAP](#)) shown in the photo on the left had no riparian buffer area. To improve the riparian area, the banks of the stream were graded back, increasing the stream width. The photo was taken shortly after the newly sloped area was seeded to grass. The streambed was not graded so as to minimize disturbance of the streambed. The forage will be mechanically harvested and cattle will not be allowed to graze the area.

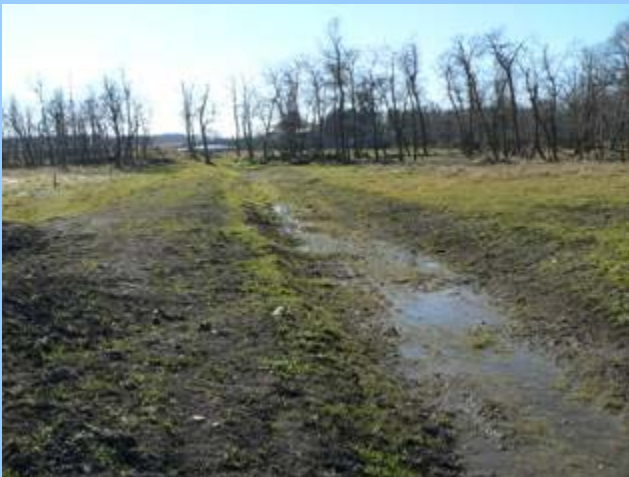
This photo depicts the drain path from the cattle containment area to the water holding pond. The main drain and drains within the cattle containment area have been fenced to eliminate any access by the cattle. The pond had to be constructed a distance away from the cattle area because of a high water table and soil conditions.

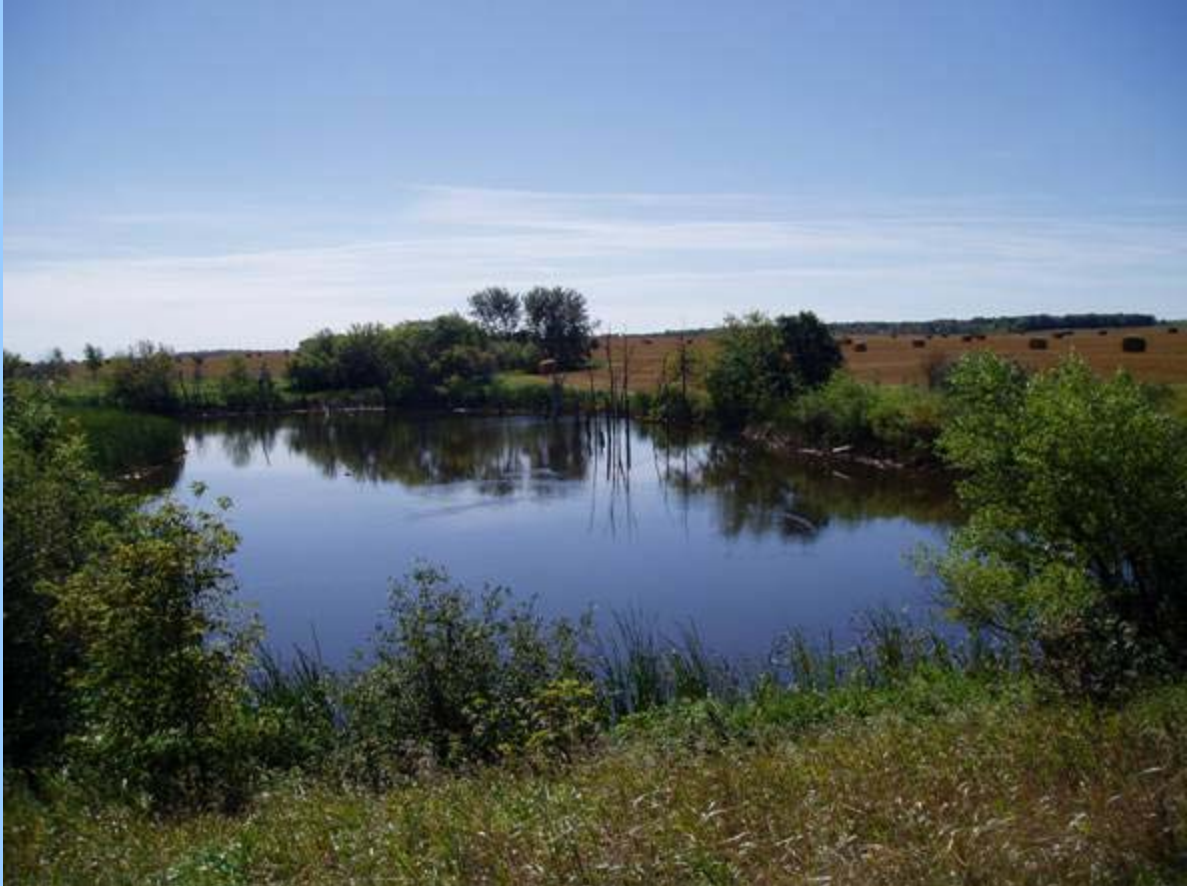
Shown in the photo is one of two small reservoirs being monitored for inflow and outflow, along with water sampling to assess the impact of the small reservoir on downstream nutrient loading. The monitoring of runoff commenced shortly after the reservoir's construction in the early 1990s, while the sampling of water flowing in and out of the reservoir was initiated in 1999. The reservoir is located at the base of the Stepler-South Tobacco Creek Watershed and will provide accumulative impact data about the BMPs incorporated in the Stepler Watershed. A second similar assessment site, the Madill Reservoir, can be found on the location map.

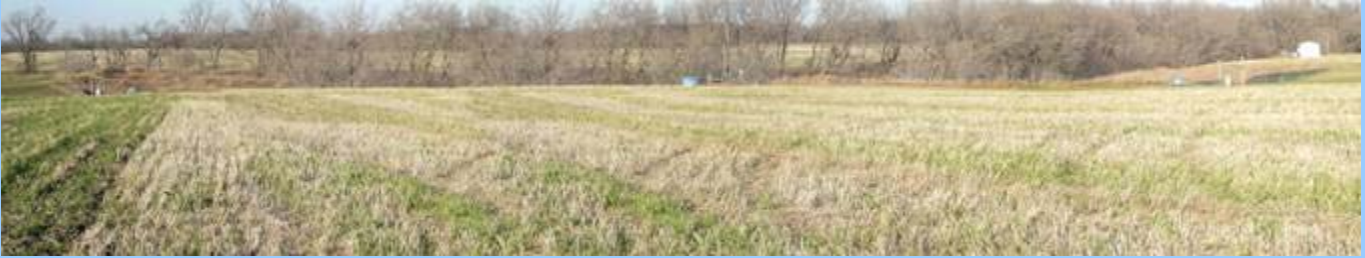
The photo shows two sub-watersheds (fields F10 and F11 [MAP](#)) used to compare the runoff and nutrient loading from a zero-tillage field and a conventionally-tilled field. The zero-till field sits on the right, the conventional-till field on the left. Runoff monitoring and water sampling equipment located on each of the sub-watersheds is visible near the top of the photo, along the field line. The project was started in the early 1990s and the two sub-watersheds were farmed similarly for four years to establish runoff and nutrient loading baseline conditions. One watershed (on the right) was then converted to zero tillage.
